SAIB: CE-10-08

SUBJ: Wings: Zodiac CH601XL and CH650 Wing Structural Modifications **Date:** November 7, 2009

SAFETY ALERT / SAFETY DIRECTIVE

ZODIAC CH 601 XL / 650	UPGRADE DRAWINGS WING SPAR & REAR CHANNEL	6-ZU-1
<small>Copyright© 2009 CHRIS HEINTZ</small>		<small>DATE: 25 JAN 2010</small>

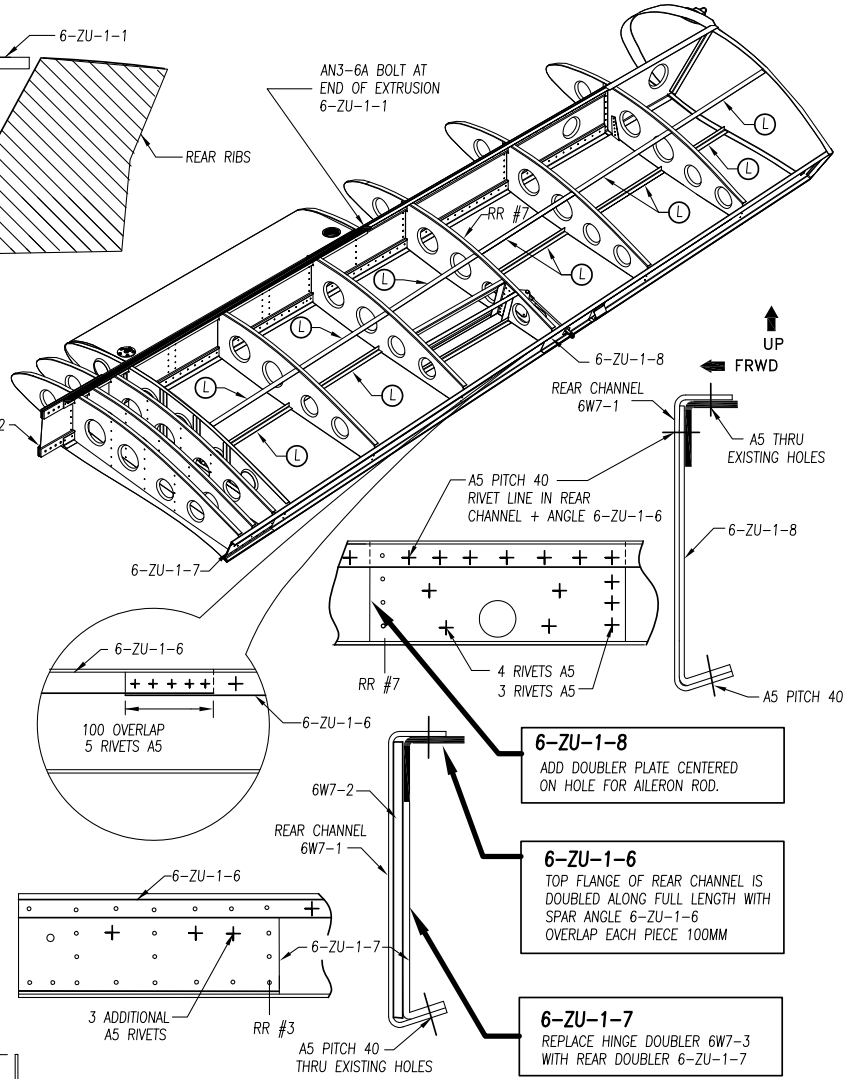
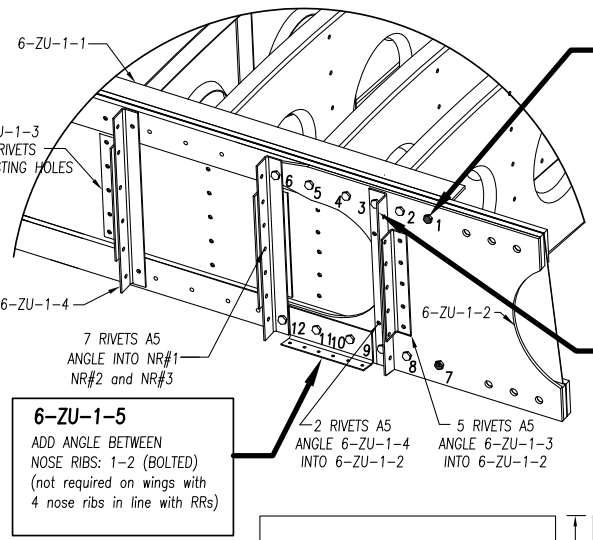
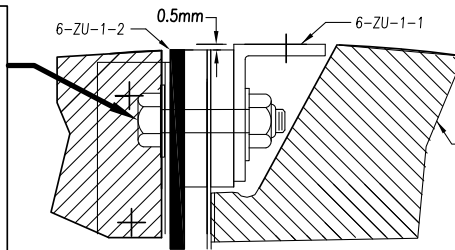
- **Wing structure:** FAA analysis shows bending loads used to design the wing structure were non-conservative and the basic static strength of the CH601XL/CH650 does not appear to meet the intent of the ASTM standards for a 600kg (1320 lb) airplane, given the current flight envelope in the Pilot Operating Handbook.

- **Structural Stability:** Other aviation authorities have noted the presence of buckling in the wing structure, including in the center section. Such structural instabilities can have a significant effect on static strength and flutter characteristics.

DRILL OUT SOLID RIVETS.
 CUT SPAR ANGLE 6W3-6 AT 1680MM FROM INBOARD END.
 TRIM BACK TOP FLANGE ON REAR RIBS TO CLEAR 6-ZU-1-1.
 INSTALL EXTRUSION WITH SOLID RIVETS MS20470AD-6-14 AND
 MS20470AD-6-15 (QTY=4) MS20470AD-6-10
 USE BOLTS IN ROOT AREA 6-ZU-1-2 AND ONE BOLT IN LIEU OF
 RIVET AT OUTBOARD END OF EXTRUSION.

DRILL OR REAM ALL BOLT HOLES TO ENSURE CLOSE TOLERANCE
 FIT OF BOLTS IN HOLES. IT IS ACCEPTABLE TO REPLACE
 SOLID RIVETS BY AIRFRAME BOLTS OF EQUAL DIAMETER.

REMOVE NOSE RIB #1, #2 and #3. DRILL
 OUT BOTTOM SOLID RIVETS TO ADD
 6-ZU-1-2 ON FRONT SIDE OF SPAR.

6-ZU-1-5
 ADD ANGLE BETWEEN
 NOSE RIBS: 1-2 (BOLTED)
 (not required on wings with
 4 nose ribs in line with RRs)

6-ZU-1-8
 ADD DOUBLER PLATE CENTERED
 ON HOLE FOR AILERON ROD.

6-ZU-1-6
 TOP FLANGE OF REAR CHANNEL IS
 DOUBLED ALONG FULL LENGTH WITH
 SPAR ANGLE 6-ZU-1-6
 OVERLAP EACH PIECE 100MM

6-ZU-1-7
 REPLACE HINGE DOUBLER 6W7-3
 WITH REAR DOUBLER 6-ZU-1-7
