SAIB: CE-10-08

SUBJ: Wings: Zodiac CH601XL and CH650 Wing Structural Modifications **Date:** November 7, 2009

SAFETY ALERT / SAFETY DIRECTIVE

ZODIAC CH 601 XL / 650	UPGRADE DRAWINGS WING SPAR & REAR CHANNEL	6-ZU-1
<small>Copyright© 2009 CHRIS HEINTZ</small>		<small>DATE: 25 JAN 2010</small>

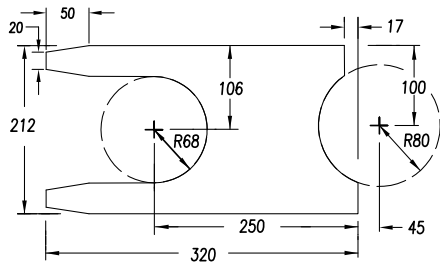
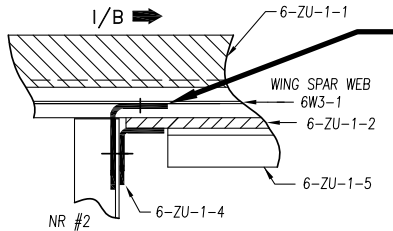
6-ZU-1-3
 REPLACE 6W3-9 WITH 6-ZU-1-3.
 TRIM 1/8" OFF END OF NOSE RIB#1 AND 2
 RIB SANDWICHED BETWEEN 6-ZU-1-3
 AND 6-ZU-1-4. RIVET TO SIDE OF RIB

6-ZU-1-2 AIRFRAME BOLTS

6-ZU-1-4
 TRIM 1/8" OFF BACK OF NR#1
 ADD .040" ANGLE TO REPLACE 6W3-9

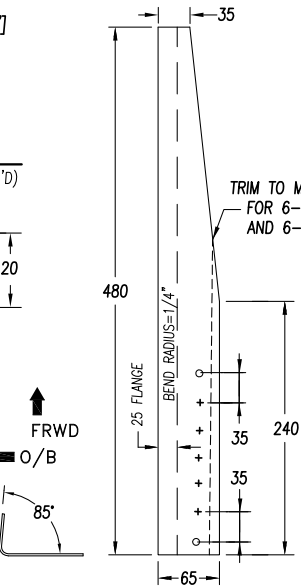
6 FRONT WING UPRIGHTS
t=.125" 6061-T6 (1L + 1R REQ'D)

5 UPRIGHT SHIMS
t=.063" 6061-T6 (8 REQ'D)
